FINAL DESIGN REPORT / ENVIRONMENTAL IMPACT STATEMENT

Appendix L – Bridge Information

Highway Project
P.I.N. 1721.51
BINs: 1033141 / 1033142
Interstate 87 (I-87) Exit 4 Access
Improvements
Albany County

BIN 1033141

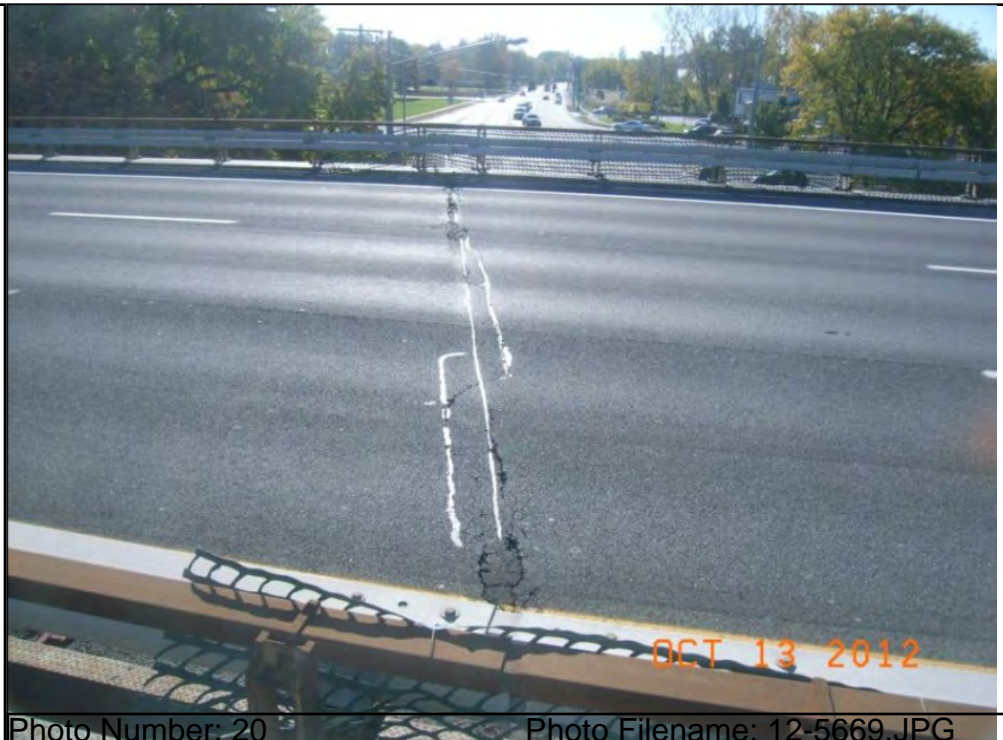
Photo Number: 20

Superstructure - Joints -
Pier 2 - from left

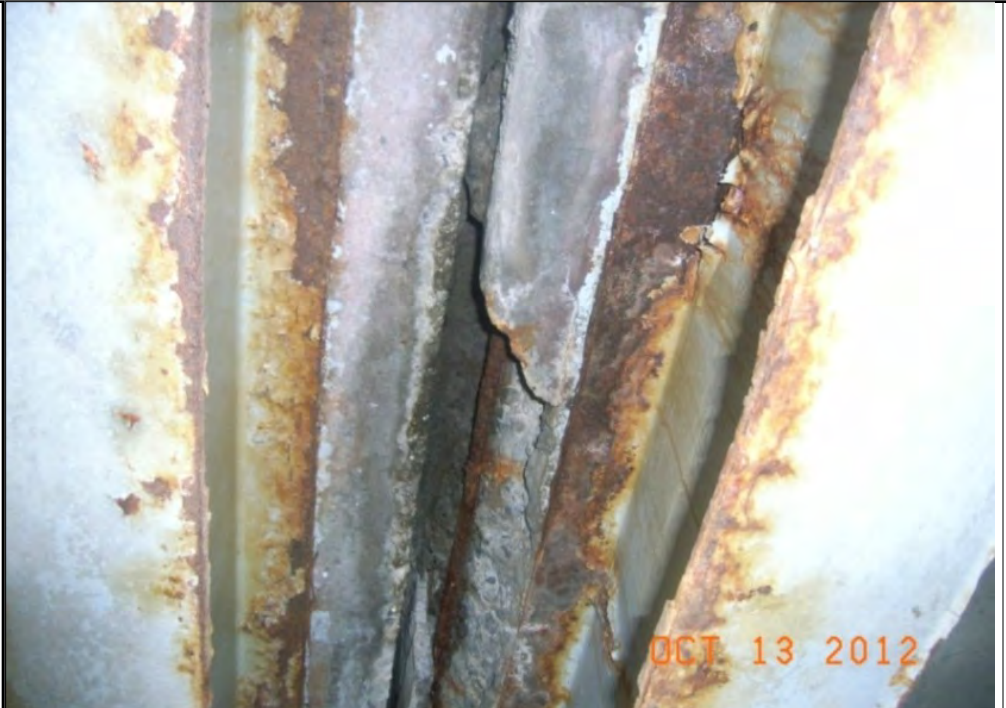
Photo Number: 21

Superstructure - Joints -
Pier 2 underside in Bay 5

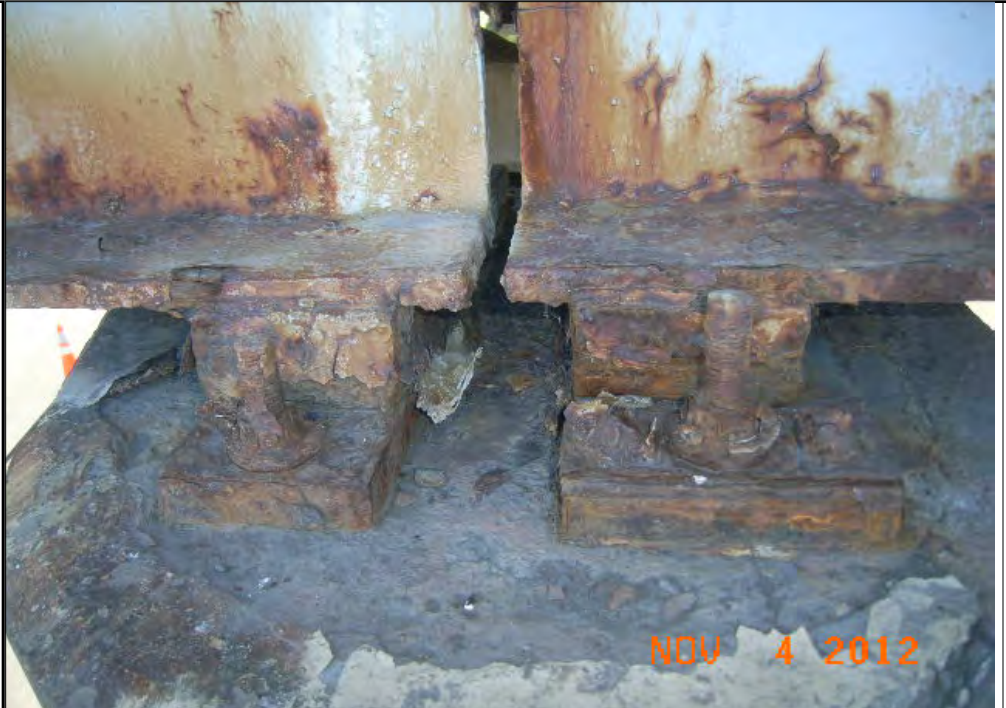
Photo Number: 22

Pier - Bearings, Bolts,
Pads - Pier 1 - Girders 1 -
left side

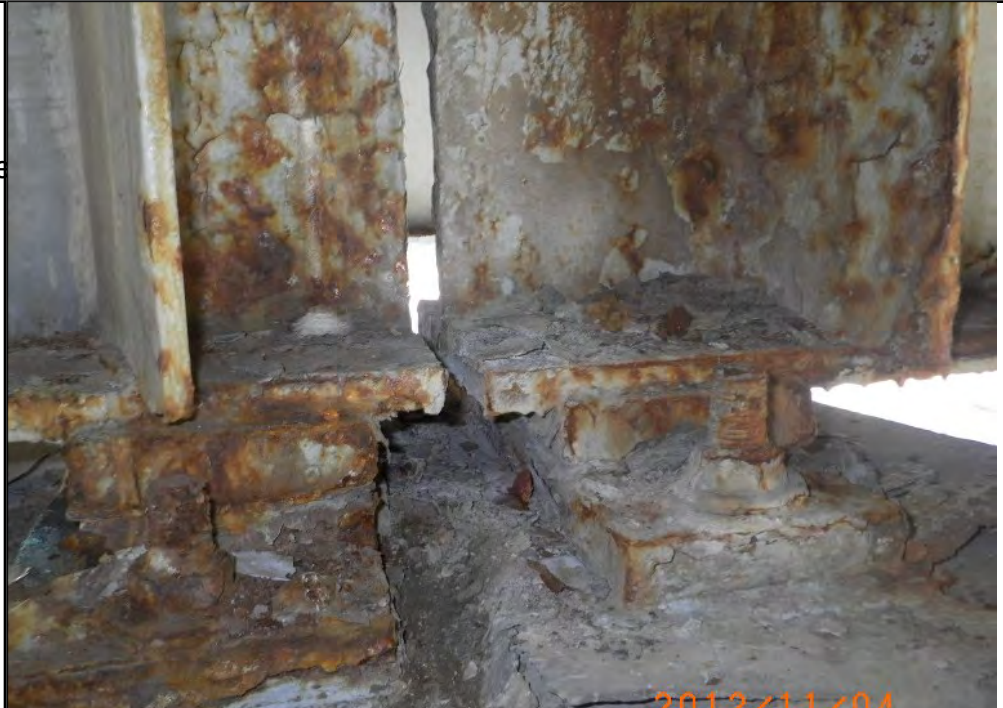
Photo Number: 23

Pier - Bearings, Bolts,
Pads - Pier 1 - Girders 3 -
left side
Superstructure - Paint -
Pier 1 - Girders 3 - left side

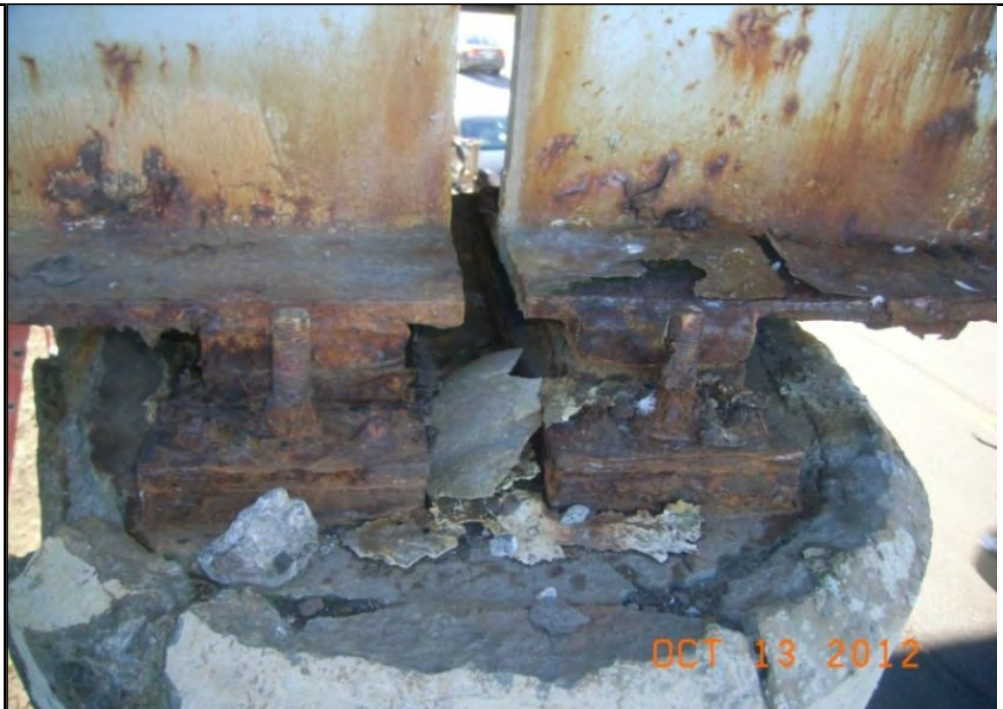
Photo Number: 24

Pier - Bearings, Bolts,
Pads - Pier 2 - Girders 1 -
left side

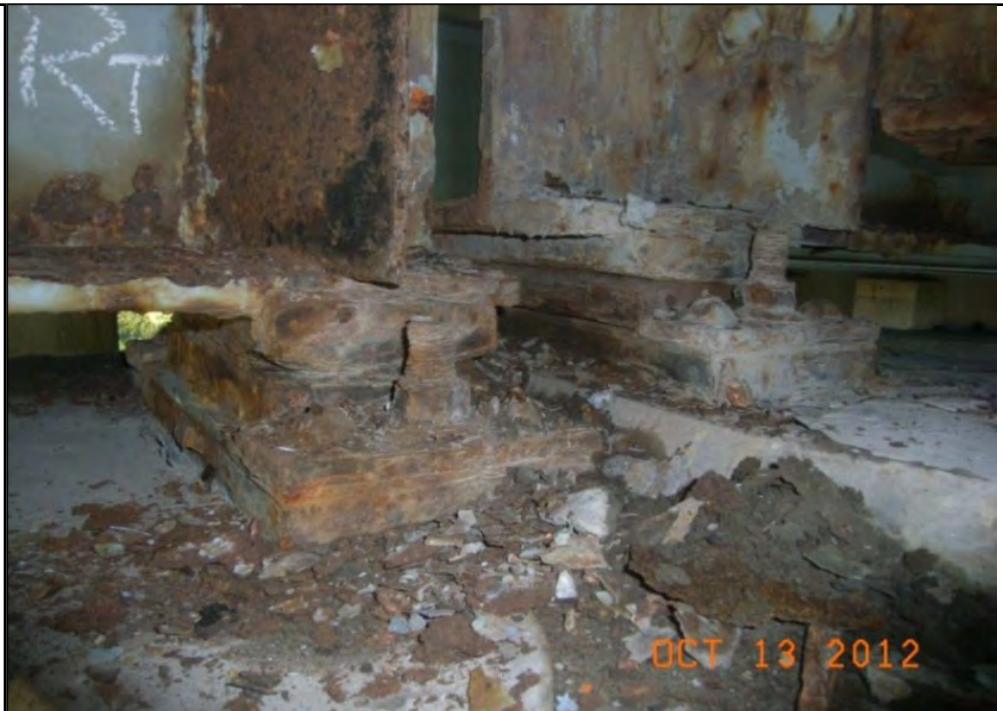
Photo Number: 25

Pier - Bearings, Bolts,
Pads - Pier 2 - Girders 5 -
right side

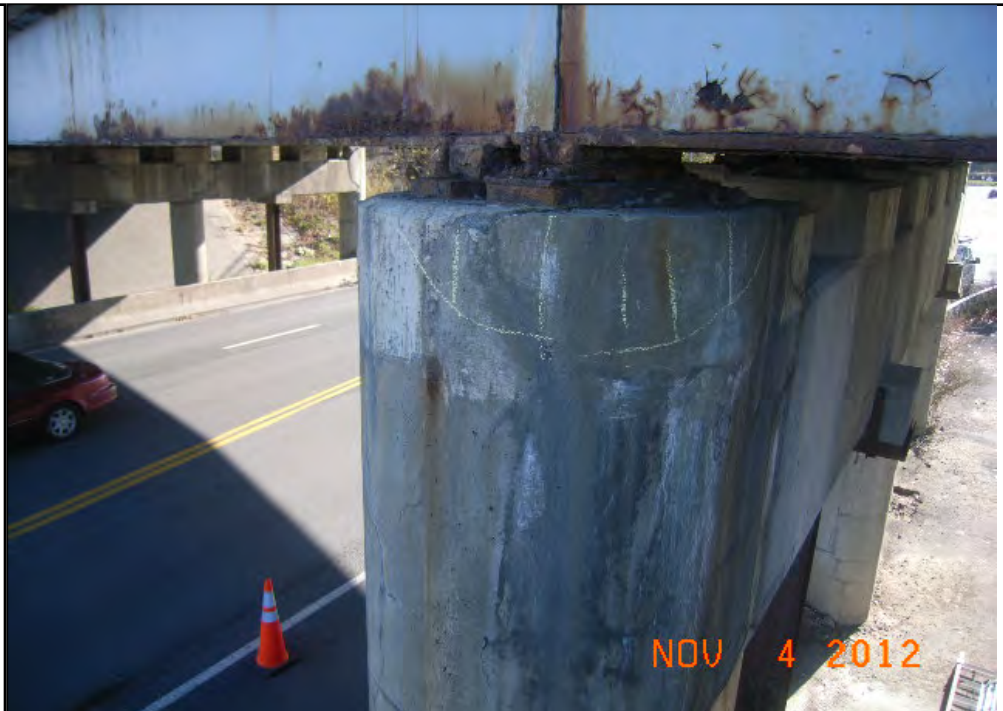
Photo Number: 26

Pier - Pedestals - Pier 1,
P1, Left face

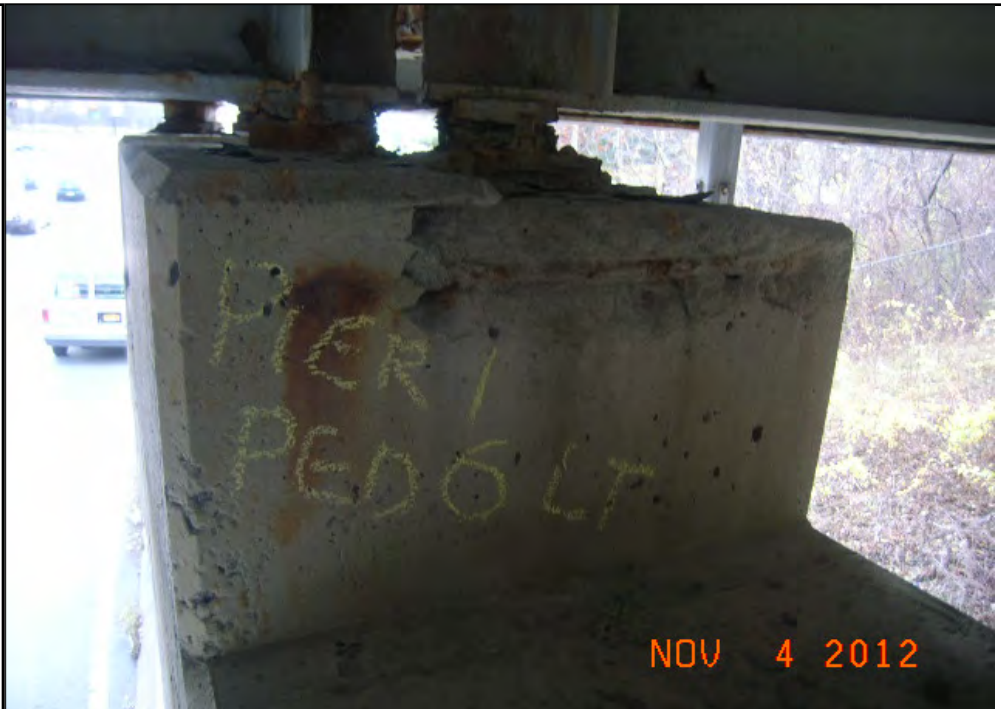
Photo Number: 27

Pier - Pedestals - P6 Left
face

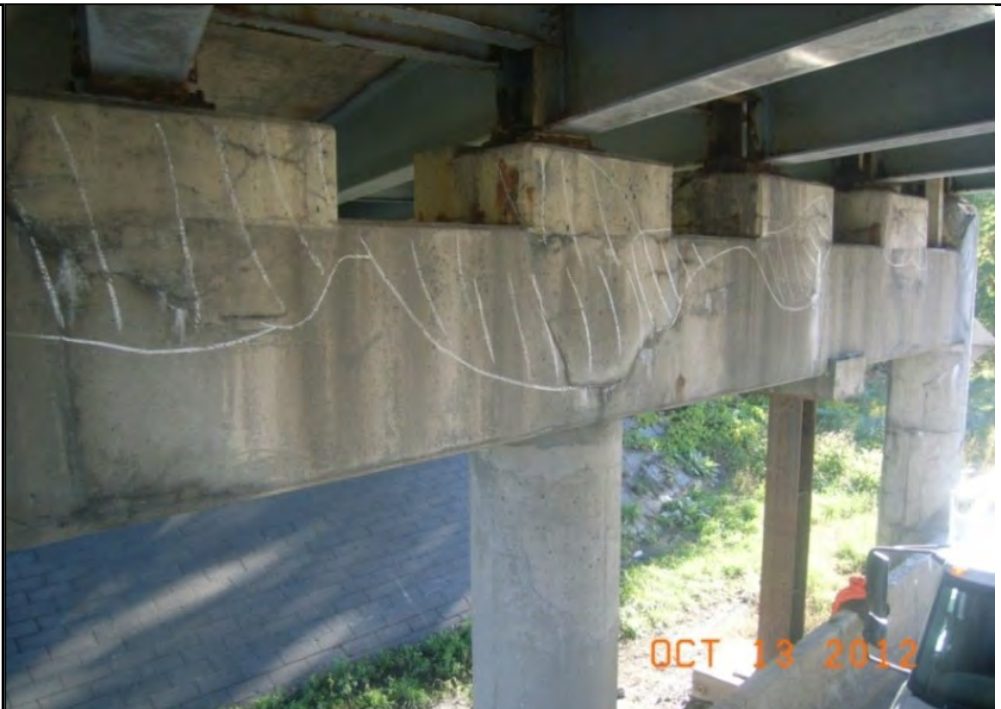
Photo Number: 28

Pier - Pedestals - Pier 2,
from P3 looking right,
begin face

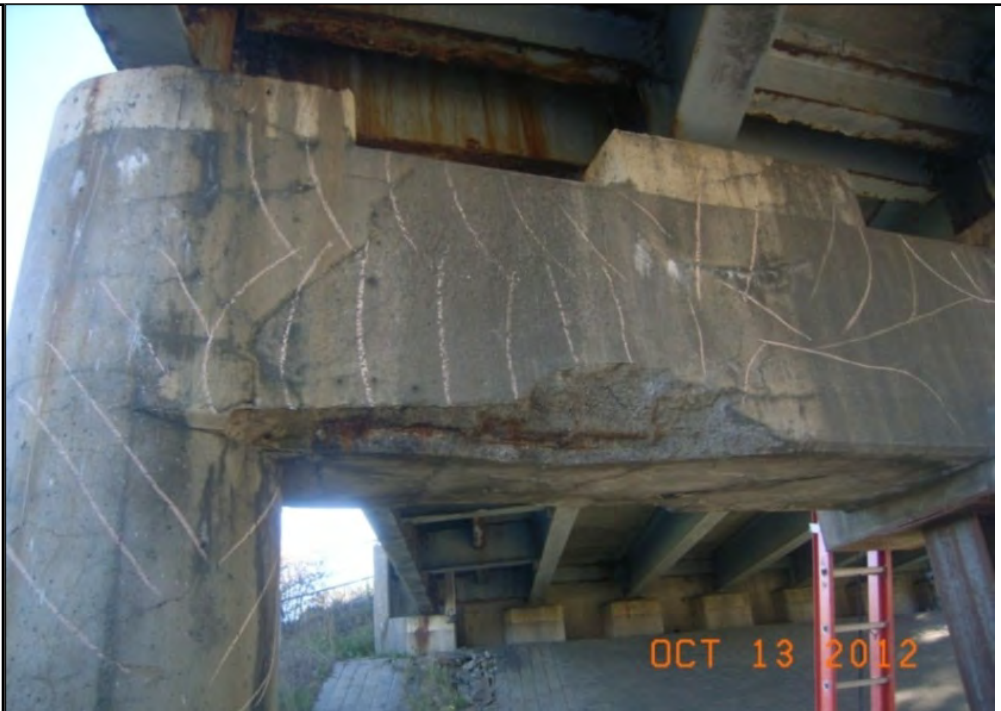
Photo Number: 29

Pier - Pedestals - Pier 2,
P1 & P2 begin face

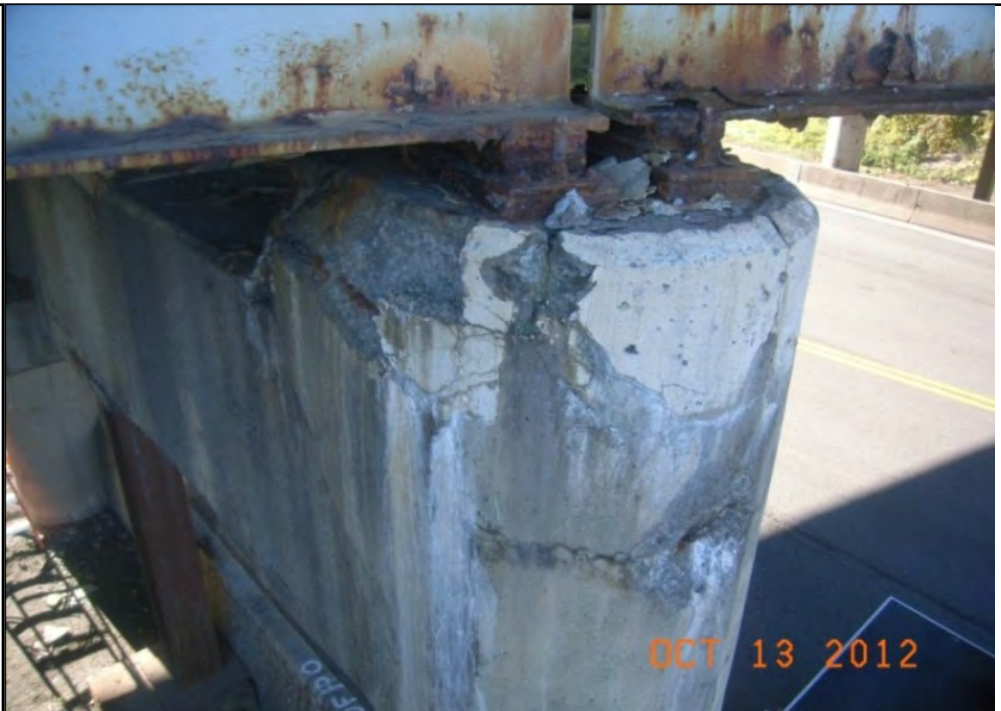
Photo Number: 30

Pier - Pedestals - Pier 2,
P1 end and left faces

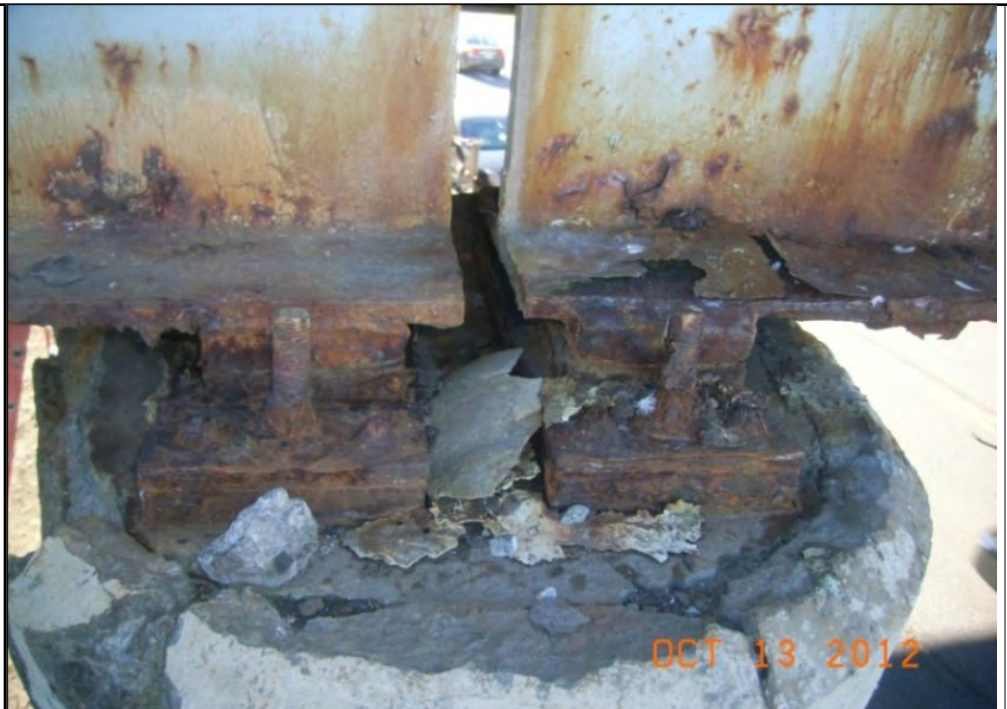
Photo Number: 31

Pier - Pedestals - Pier 2,
P1 top from right

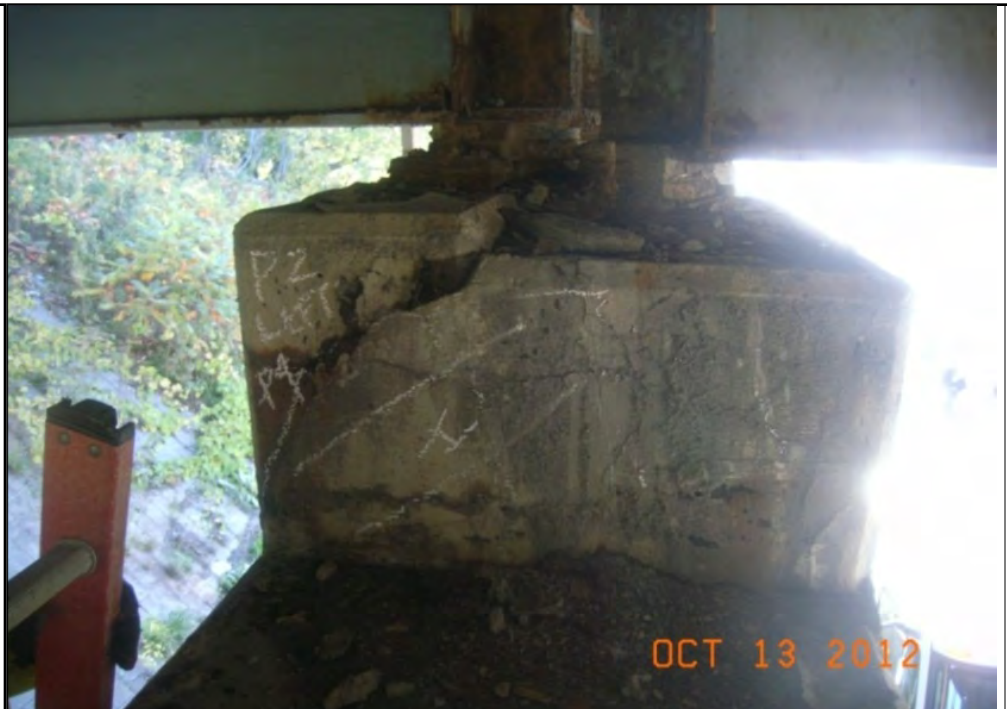
Photo Number: 32

Pier - Pedestals - Pier 2,
P5 left side

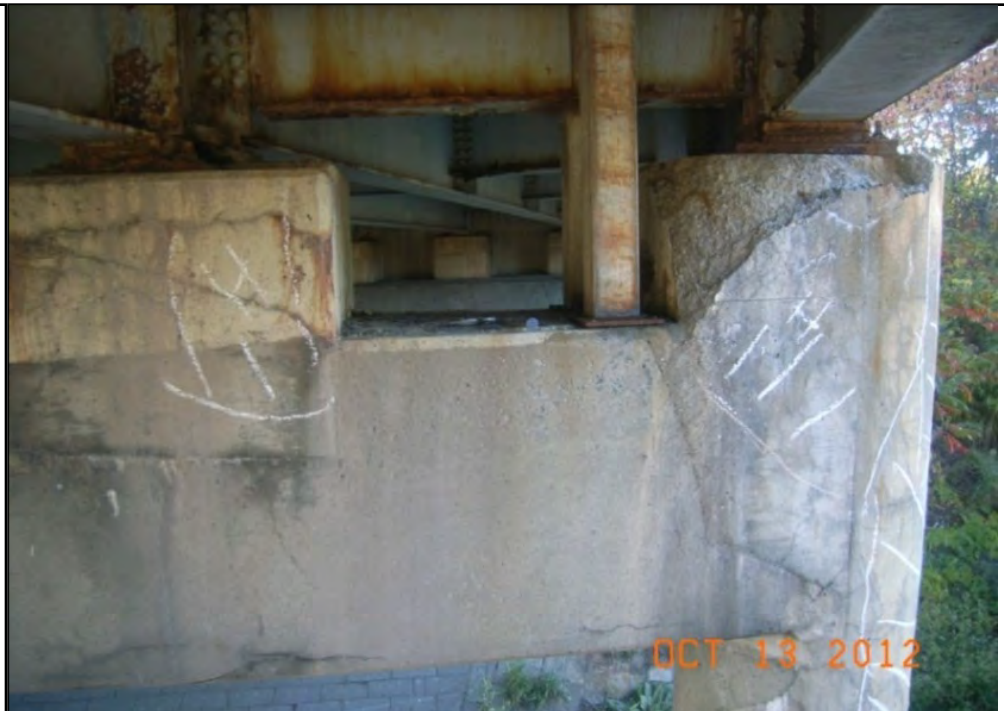
Photo Number: 33

Pier - Pedestals - Pier 2,
Pds P6 & P7 begin side

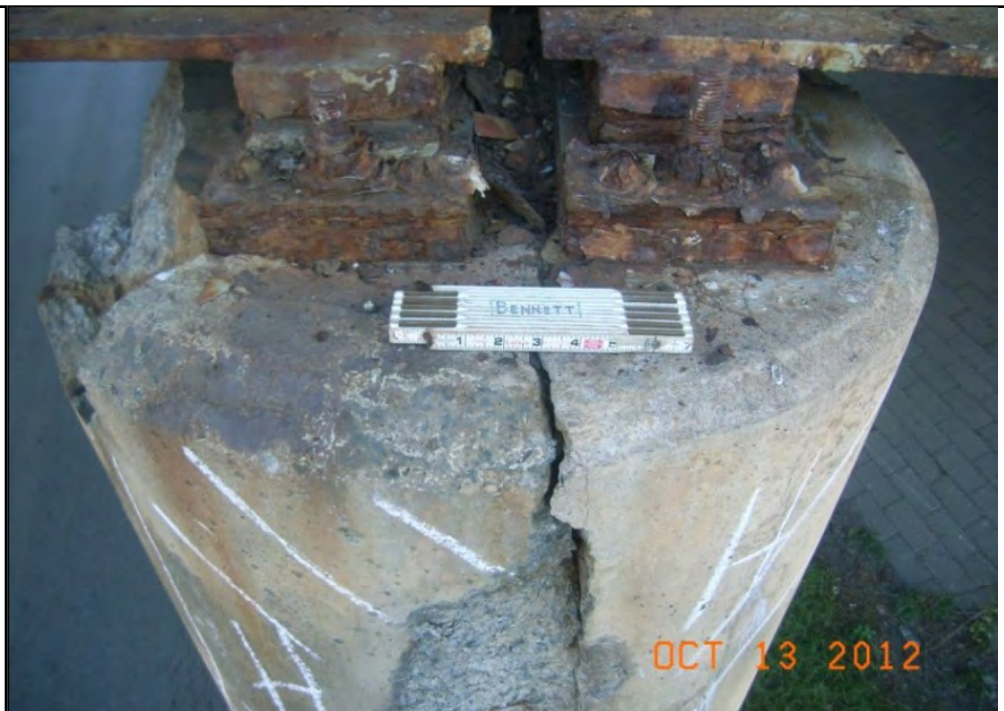
Photo Number: 34

Pier - Pedestals - Pier 2,
Pd P7 right top side

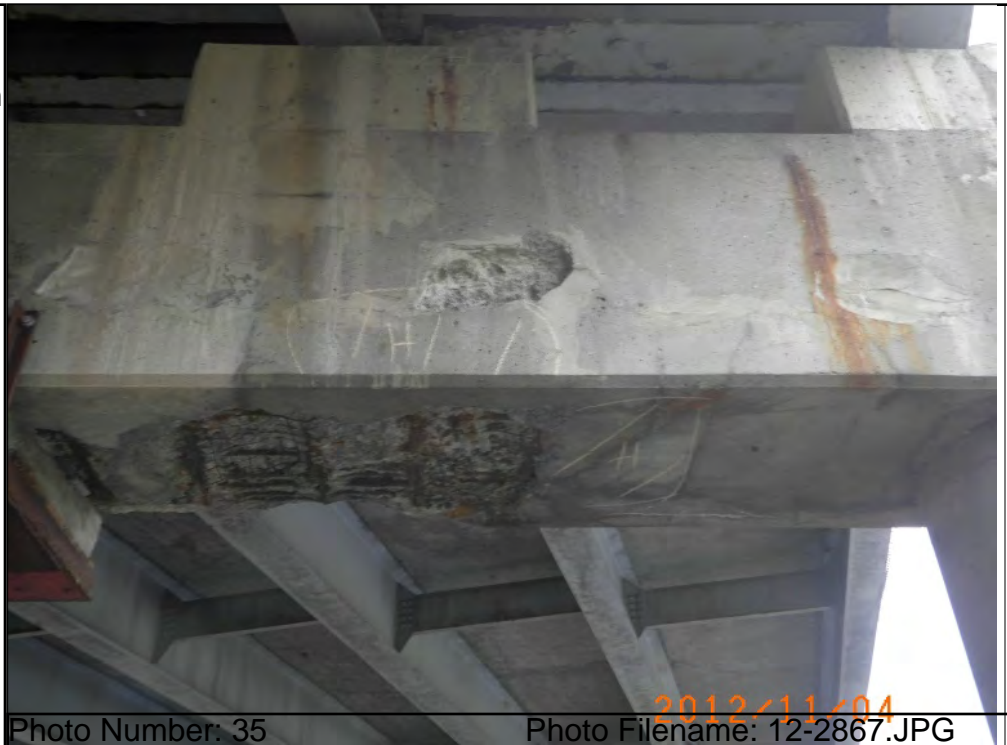
Photo Number: 35

The CAPs and COLUMNS of both piers contain similar deficiencies, but the cap of Pier 1 is in worse condition.

Pier - Cap Beam - Pier 1
- between Bay 2 Temp
Steel Column and Column
3 - Begin face

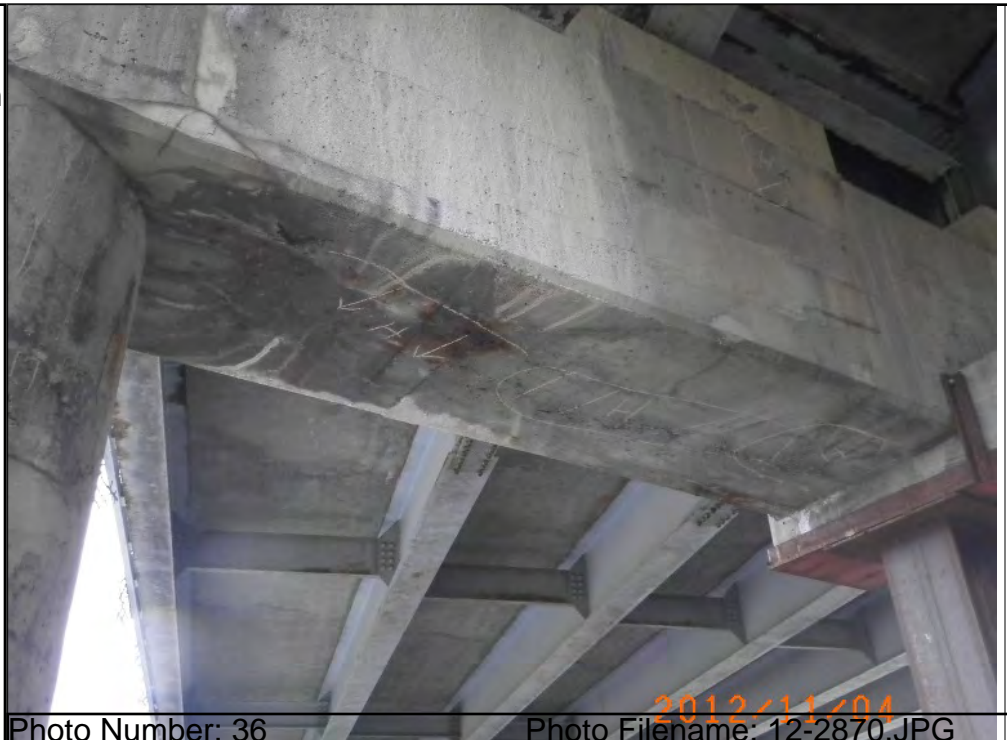
Photo Number: 36

Pier - Cap Beam - Pier 1
- between Column 1 and
Bay 1 Temp Steel Column
- Begin face

- The sides of the cap contain a spalled area on the Begin face - about 1 square foot at mid-height in Bay 2 to the right of the temporary steel column - photo 12-2867

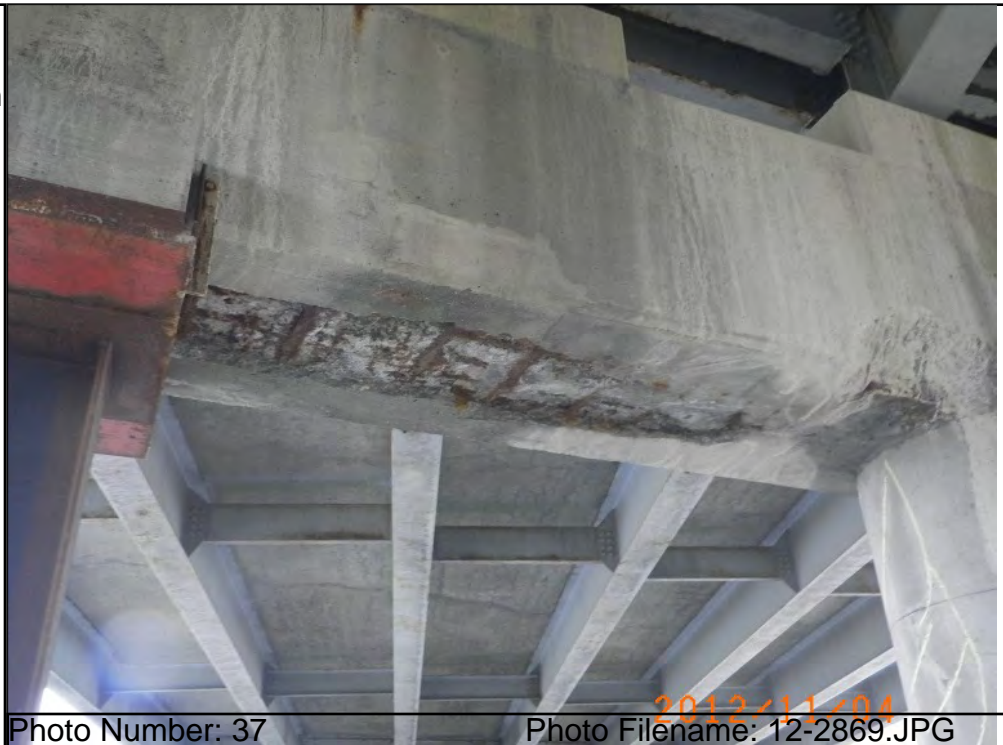
Photo Number: 37

Pier - Cap Beam - Pier 1
- between Bay 1 Temp
Steel Column and Column
2 - Begin face

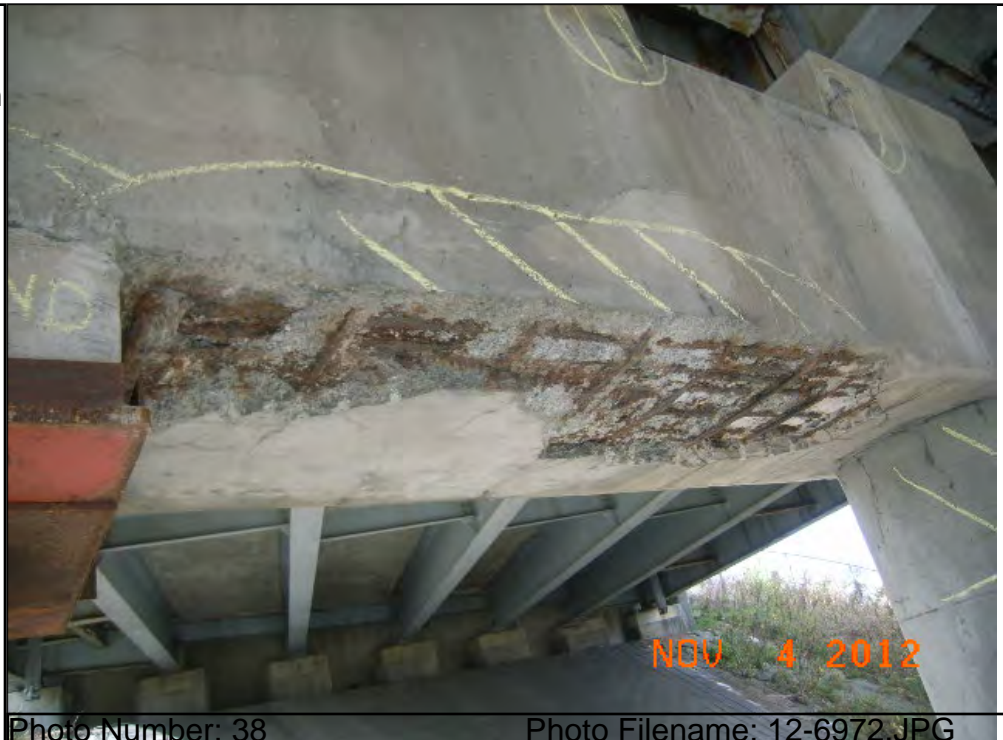
Photo Number: 38

Pier - Cap Beam - Pier 1
- between Bay 2 Temp
Steel Column and Column
2 - End face

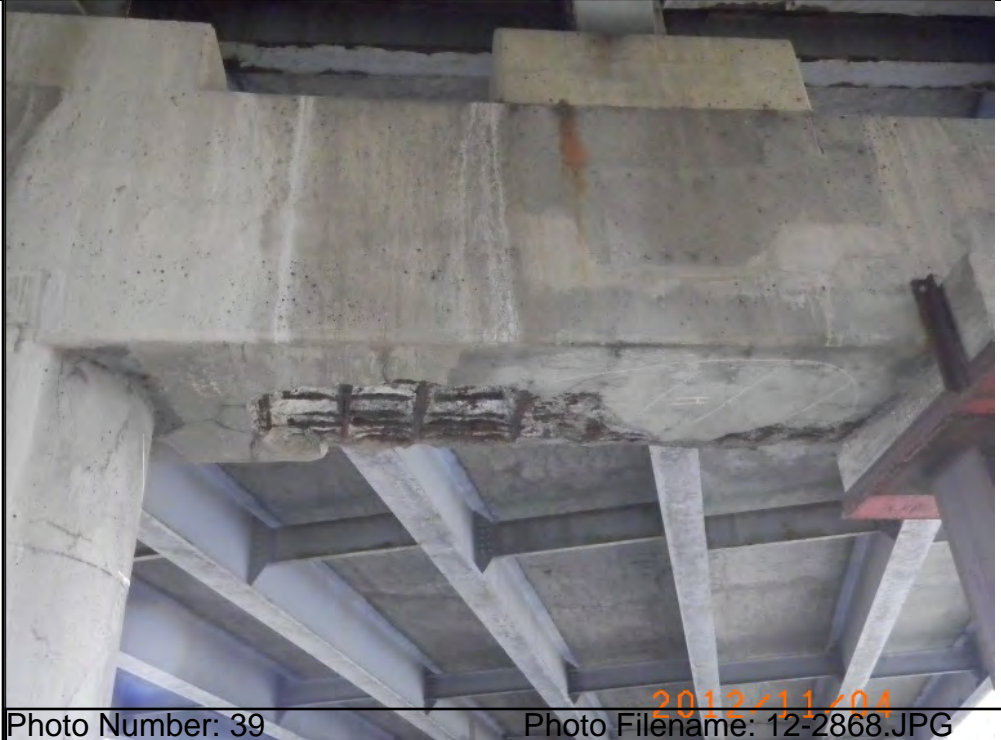
Pier - Cap Beam - Pier 1
- between Column 2 and
Bay 2 Temp Steel Column
- Begin face

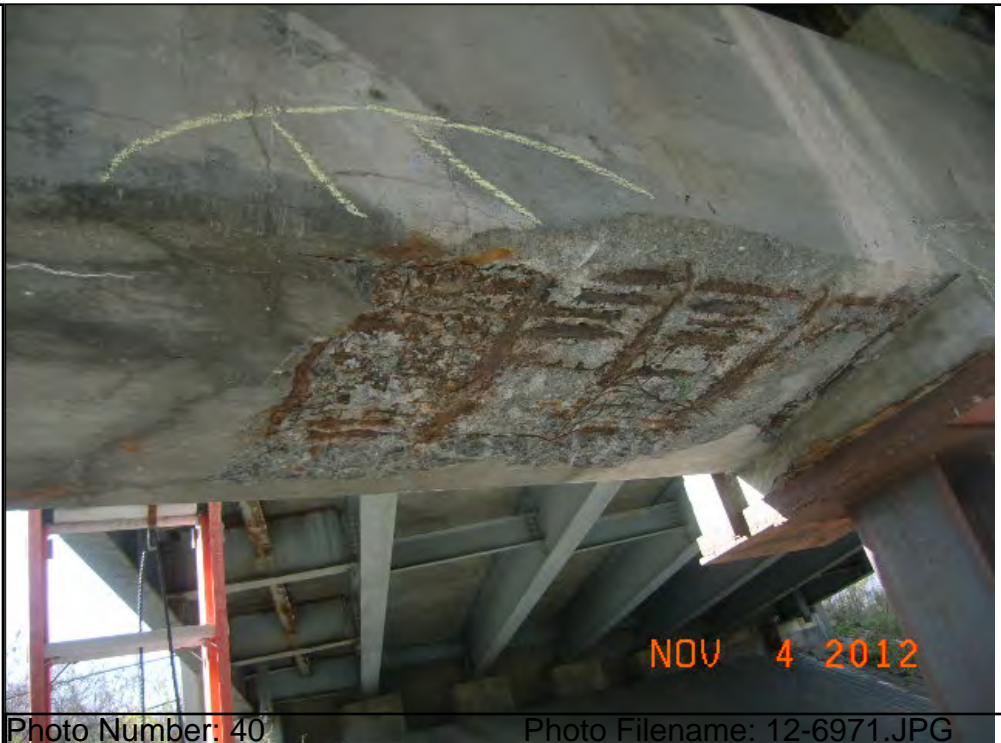
Pier - Cap Beam - Pier 1
- between Bay 2 Temp
Steel Column and Column
3 - End face

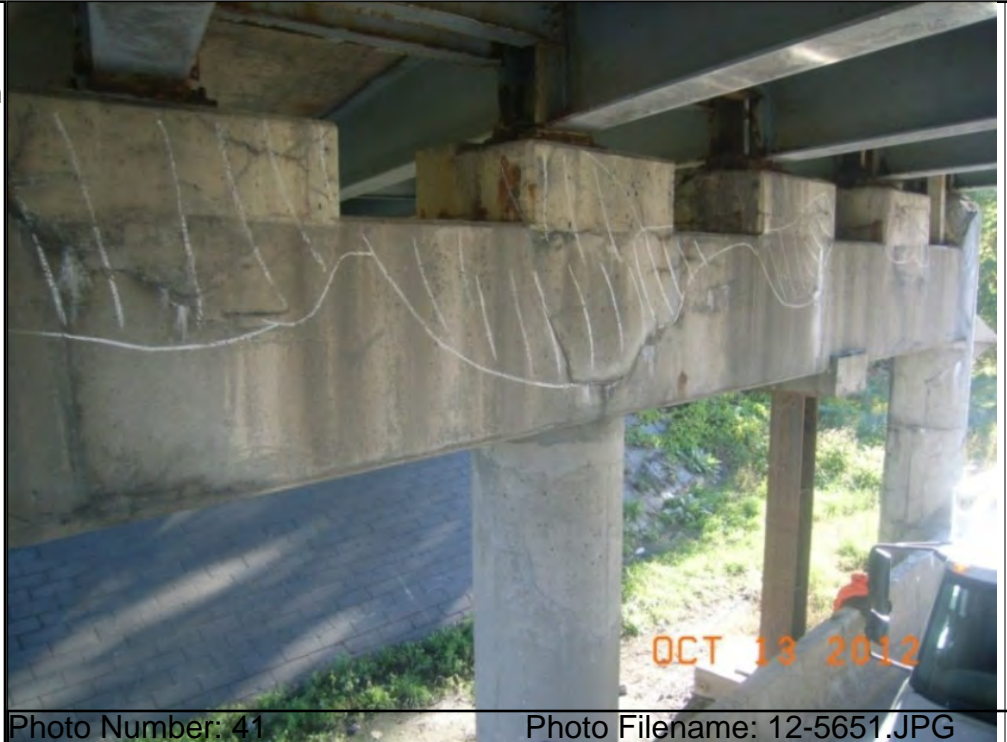
Photo Number: 41

Pier - Cap Beam - Pier 2
- between Bay 1 Temp
Steel Column and Column
3 - Begin face

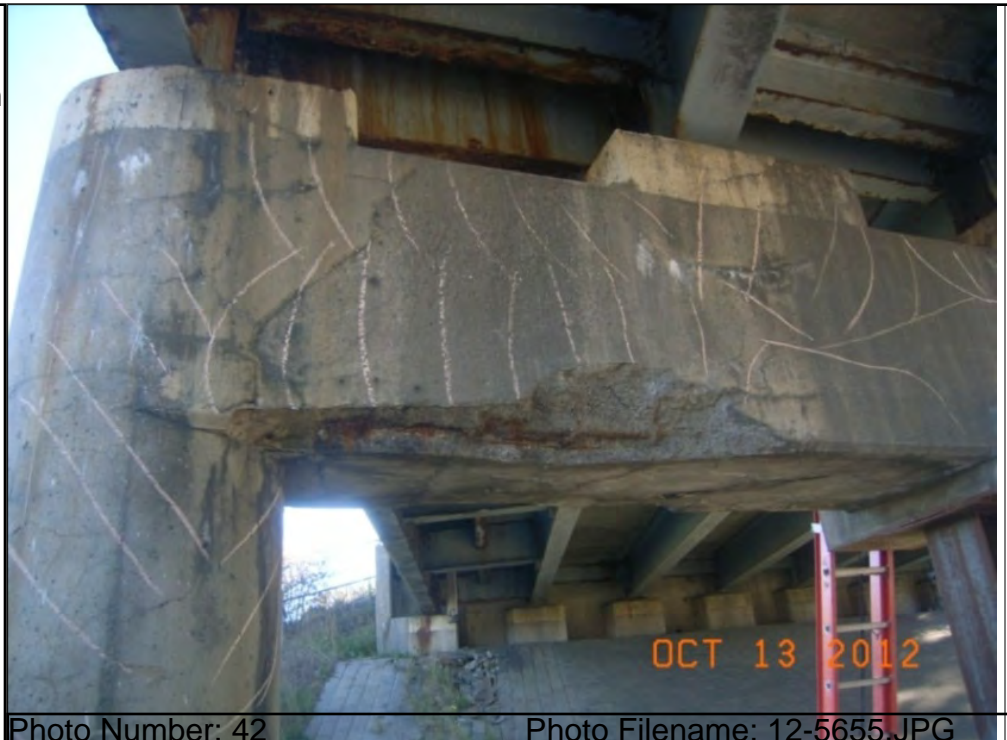
Photo Number: 42

Pier - Cap Beam - Pier 2
- between Column 1 and
Bay 1 Temp Steel Column
- Begin face
Pier 2 - Column 1 Begin
top

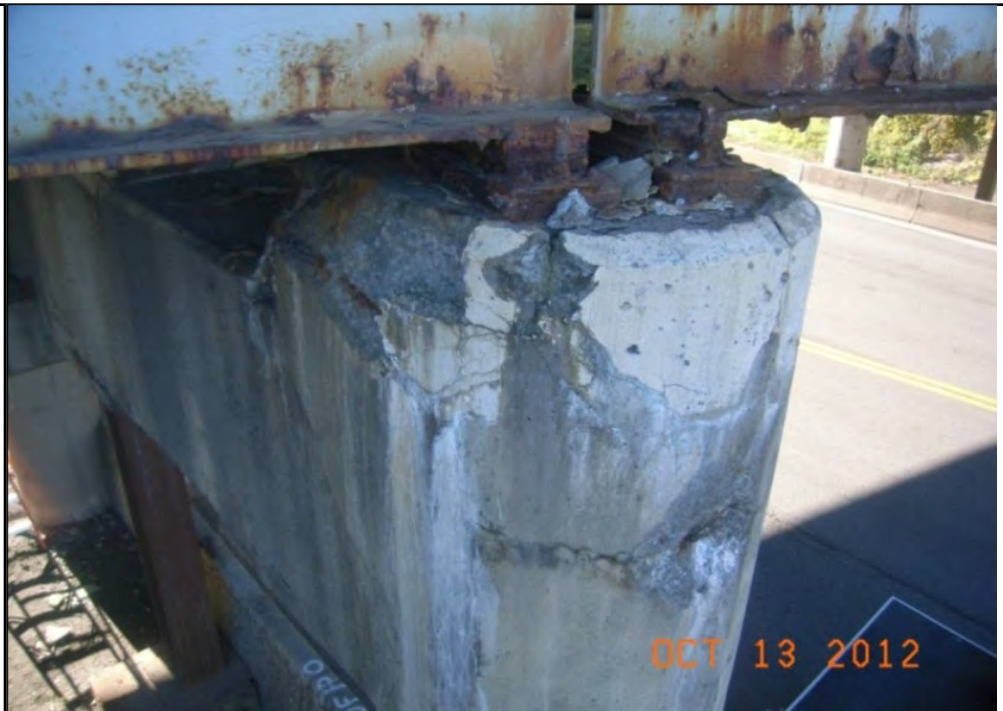
Photo Number: 43

Pier - Cap Beam - Pier 2
- Left face

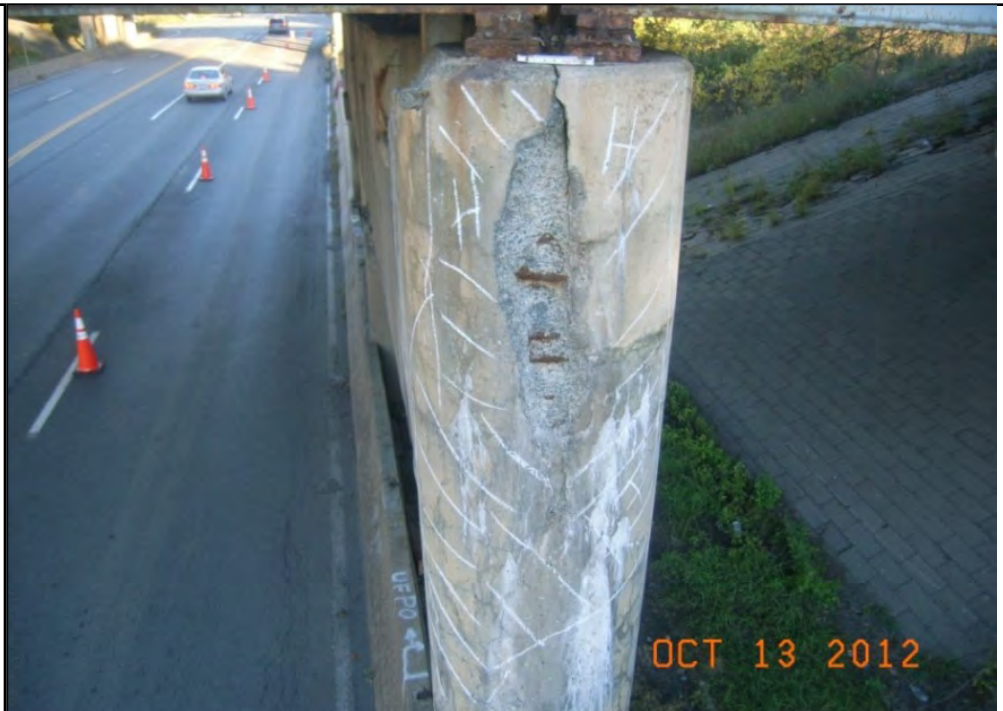
Photo Number: 44

Pier - Cap Beam - Pier 2
- Right face

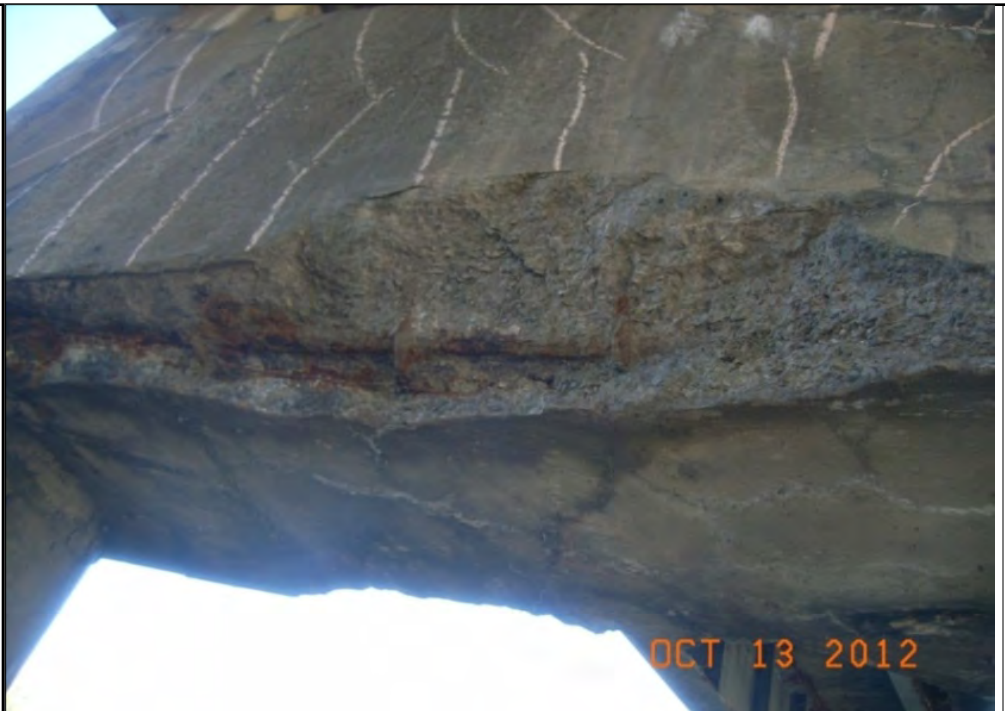
Photo Number: 45

Pier - Cap Beam - Pier 2
- between Column 1 and
Bay 1 Temp Steel Column
- Begin and bottom
face

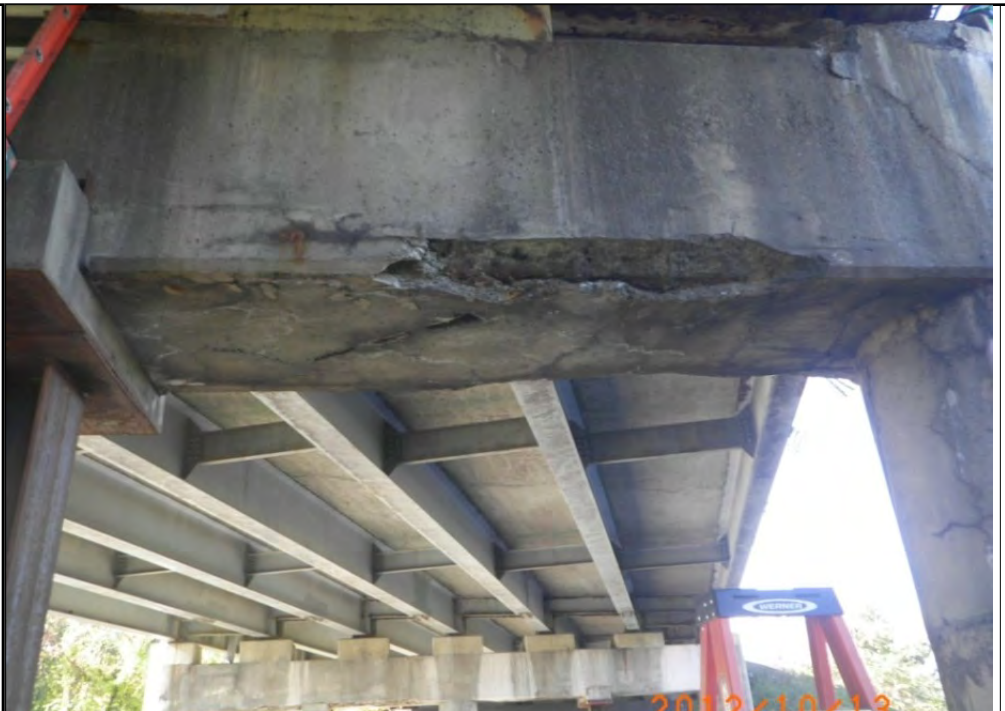
Photo Number: 46

Pier - Cap Beam - Pier 2
- between Column 1 and
Bay 1 Temp Steel Column
- End and bottom
face

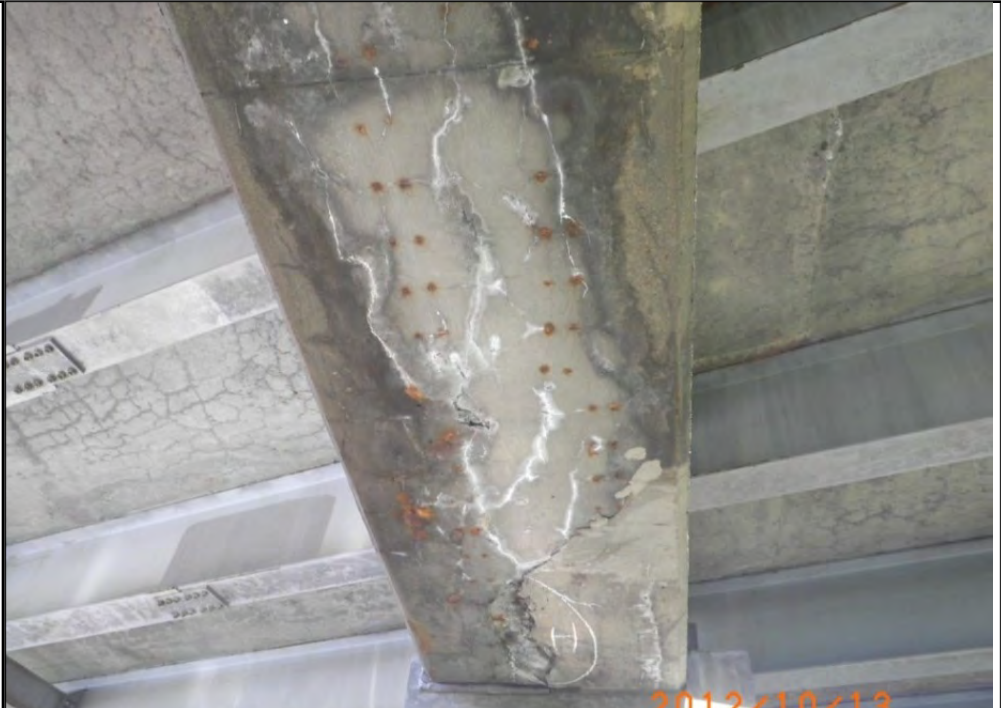
Photo Number: 47

Pier - Cap Beam - Pier 2
- between Bay 1 Temp
Steel Column and Col 2 -
bottom face

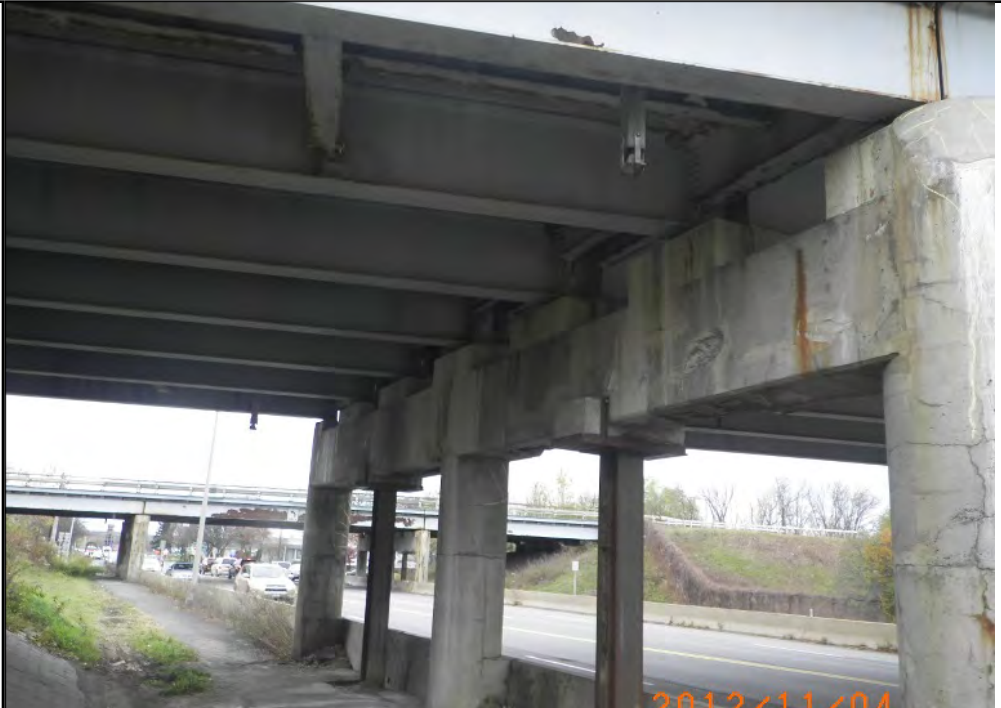
Photo Number: 48

Pier - Columns - Pier 1 -
Begin face from right

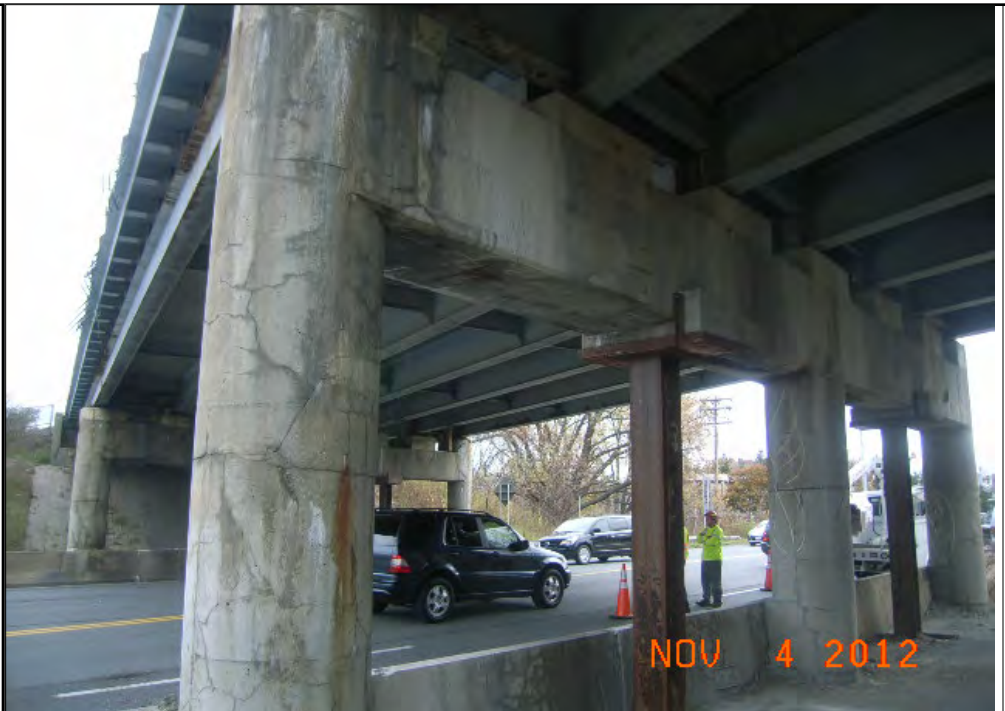
Photo Number: 49

Pier - Columns - Pier 1 -
Begin face from left

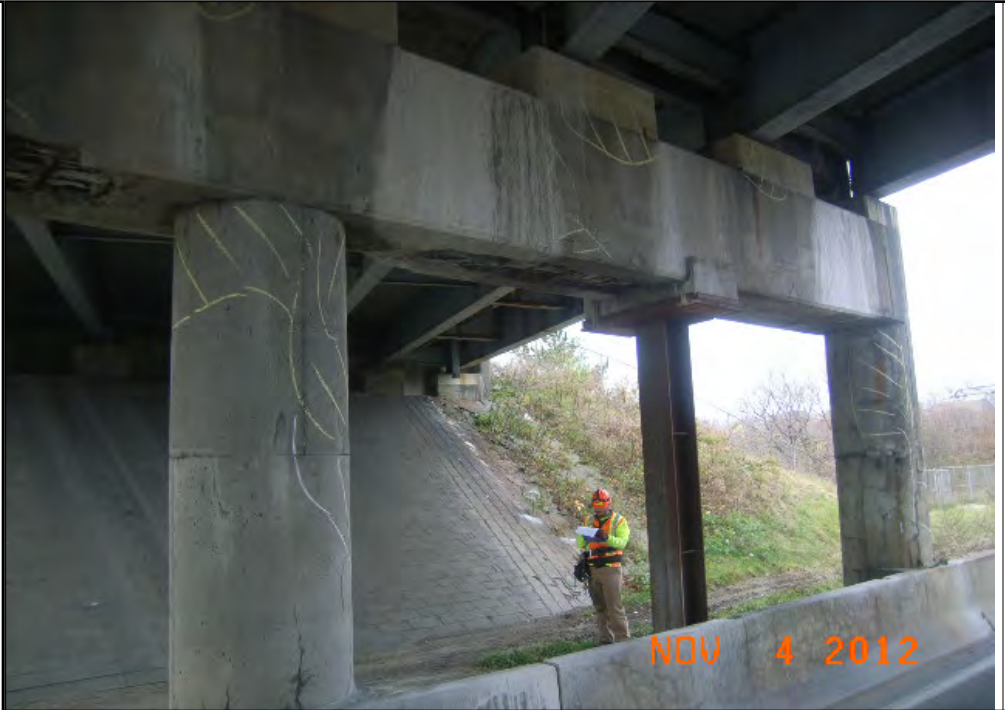
Photo Number: 50

Pier - Columns - Pier 1 -
End face of left half
